COILED TUBING

Newly completed well brought online by milling fluid loss control valve

Country: UK

Year: 2021

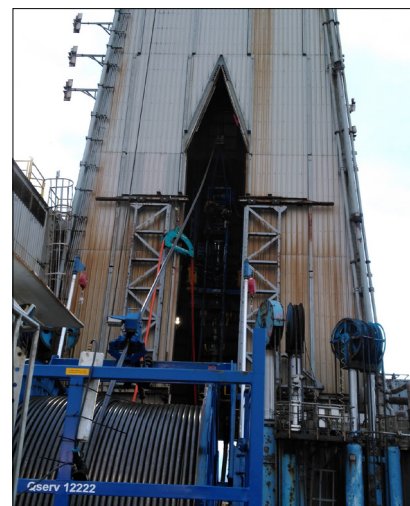
Coiled tubing rig up

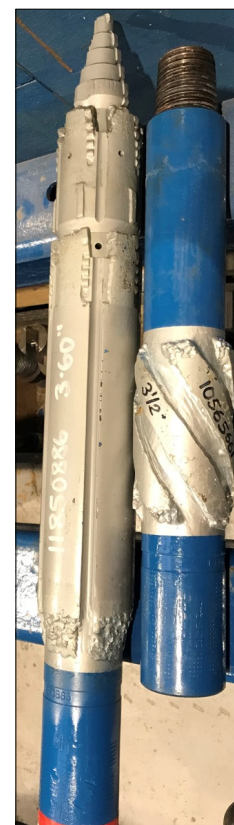
Milling tool

All operations were performed in a safe and efficient manner. Coiled tubing cleaned down to the top of the FLCV, thus gaining access for subsequent operations. After failed attempts to mechanically shift the valve open, it was then decided to mill it. The milling operation successfully removed the FLCV in less than 1 shift (<12hrs). The use of a specialist mill bit, designed specifically for the removal of such valves, proved invaluable during these operations. Finally, the well was lifted into production. This thorough planned approach precluded the necessity to mobilise more equipment or execute additional runs and ensured a successful job outcome was achieved.
