# CASE STUDY

## PRIME Technology Platform executes metal milling operation with surgical accuracy to recover well access

Precise in-well machining of jammed lock mandrel component enables removal of a retrievable downhole safety valve, facilitating well access for required gas lift valve adjustments

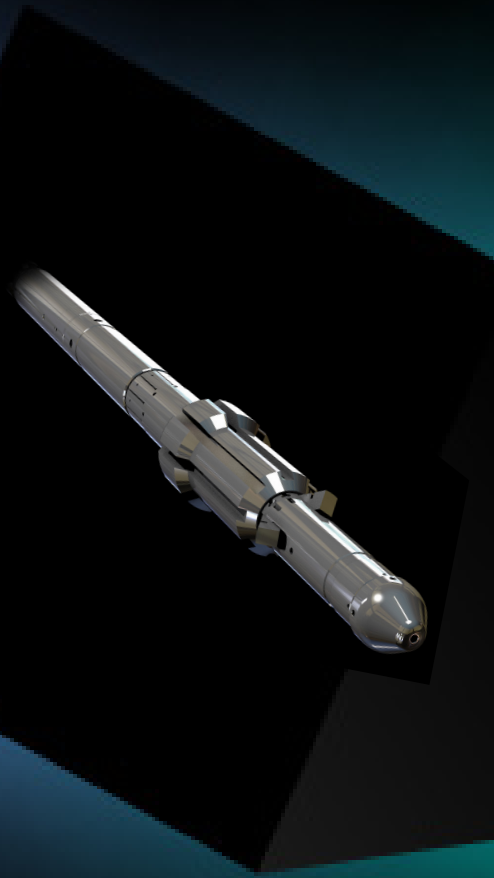
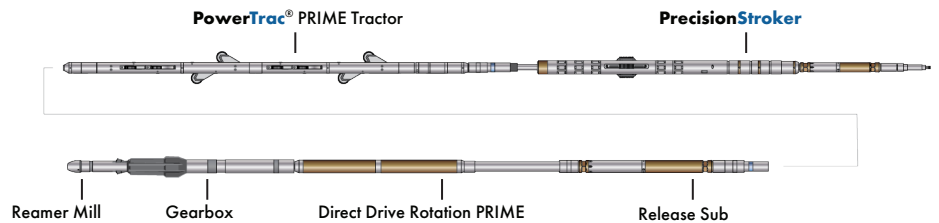
Toolstring for the milling operation

For the cutting phase, a no-go sub was added to the DECT to ensure exact placement of the blade at the bottom of the inner sleeve that was to be cut. For the milling phase, the **PrecisionStroker** was utilized in conjunction with the highly instrumented PRIME Technology Platform. This was coupled with a specifically designed reamer mill, adapted from field proven technology used in coiled tubing applications. Again, a no-go housing was added to position the mill at the precise depth within the DHSV lock. Furthermore, the milling segments were designed to be retracted during run-in-hole, only to be extended on command using the **PrecisionStroker** once at target depth. The **PrecisionStroker** was also used to position the milling segments precisely against the expander mandrel to millimeter accuracy. Once in position, and with e-line tension holding the toolstring in place, the **PrecisionStroker** was then deactivated and the **PowerTrac**® PRIME and DDR PRIME powered up – the tractor to provide a free-rolling rotational anchor and the DDR device to provide the prescribed Torque and RPM. Stipulated winch tension would provide the required weight on bit.

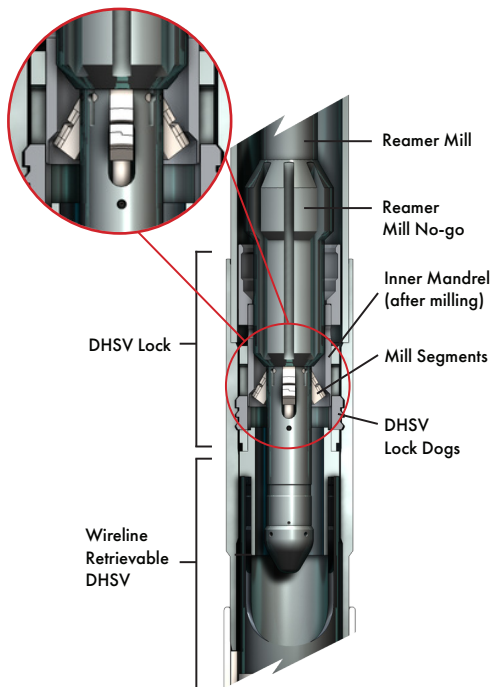
Reamer mill and DHSV lock components – shown with milling of inner mandrel completed

- Firstly to cut the inner lock mandrel using a modified Downhole Electric Cutting Tool (DECT), and retrieving this inner mandrel to expose the expander mandrel within.
- Secondly to back mill a minimum of 8mm from the lower part of the expander mandrel, leaving 1 mm of the mandrel in place – this to ensure the dogs wouldn't release during milling, but would collapse with jarring of the mandrel during a subsequent DHSV retrieval run.

Extensive full scale testing was done in Altus Intervention's test well prior to mobilization. A well specific procedure was compiled leaving nothing to chance. All steps of the operation were executed as prescribed, replicating the parameters established during the testing. Tool data and surface control available with the Cutter, Stroker, Tractor and DDR ensured all steps were monitored and controlled in realtime. Upon successful milling of the expander mandrel, the DHSV lock required only two relatively light jars to release, and the retrievable DHSV assembly was successfully removed from the well. This enabled the client to proceed with the original intervention workscope, adjusting the GLVs as required. Following this, a new wireline retrievable DHSV was installed and the well was put back onto production.
